# PORTSMOUTH GIVIG CENTER

# CONDITION ASSESSMENT

**Final Submittal**

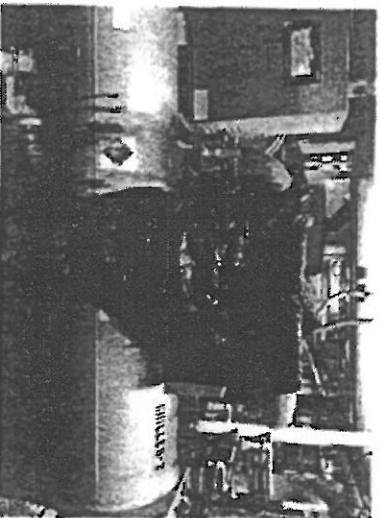
At the time of the visit the chiller was not operational. Oil pressure alarm was on the chiller control screen. The chiller has reached its expected service life of 25 years.

Chiller appears to be in poor condition.

Have the chiller serviced and repaired. Plans should be made to replace the chiller in the near future.

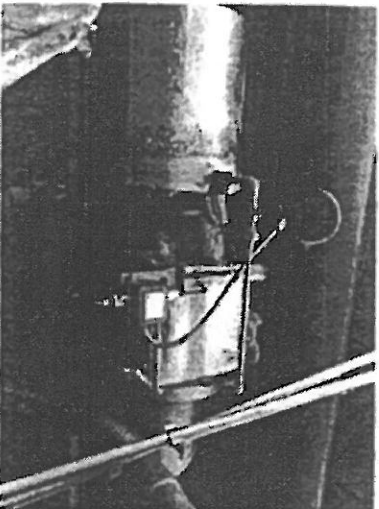
Chiller 2 circulating pumps (located directly above the chiller)

Primary chilled water pump above C-2 appears to be in poor shape. Visible leaks, uninsulated and corroded.

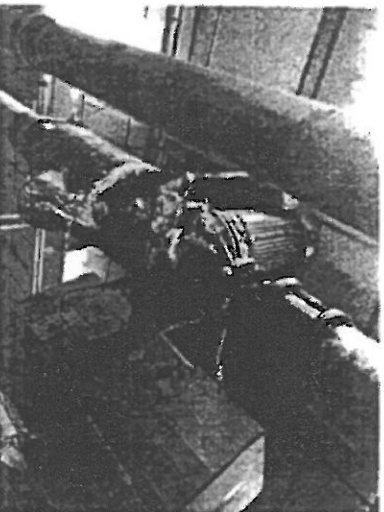
#### Pump serving the Jail building

Dual Temperature pump serving the jail motor has bad bearings (very noisy operation), is very badly corroded and has visible leaks.

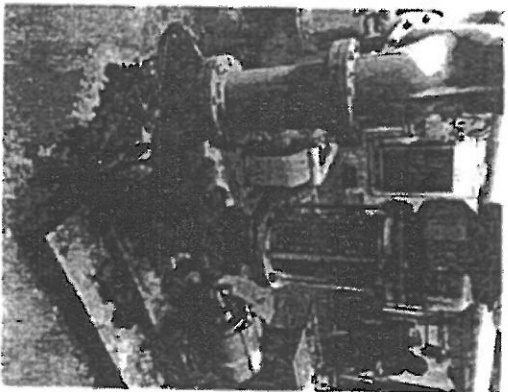
Disassembled Pump P-1

Hot water pumps, both show signs of leaks and corrosion. Exact age is not known but they appear to be over 20 years old. Expected service life for this type of equipment is 20 years. One of the pumps (P-1) was disassembled during the site visit. Both pumps are in poor condition and should be replaced.

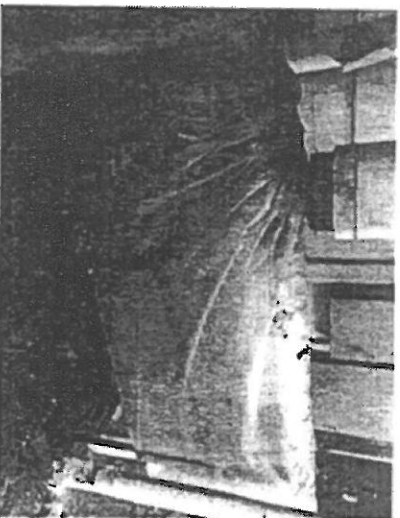
#### Domestic hot water heat exchanger

Domestic hot water heat exchanger is covered with plastic to protect it from water leaks through building expansion joints. It appears to be operational but not in a good condition. Recommend eliminating it once it fails, and installing a new domestic hot water heating system, which would also eliminate the need to run a very large heating hot boiler in the summer to provide domestic hot water.

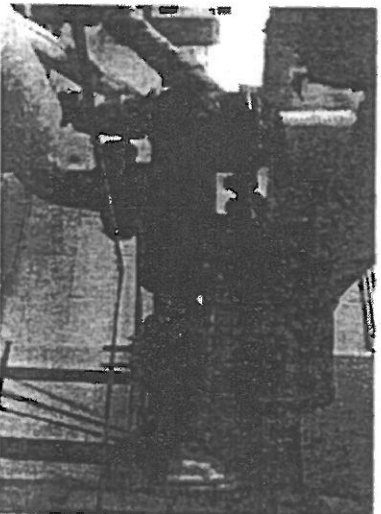
Dual temperature switch over valves do not function and the switch over from heating to cooling needs to be done manually. The valve non-functioning pneumatic actuator is being held together by a strap. When the system is switched over, according to maintenance personnel, it causes relief valves to open due to differential in two system pressures.

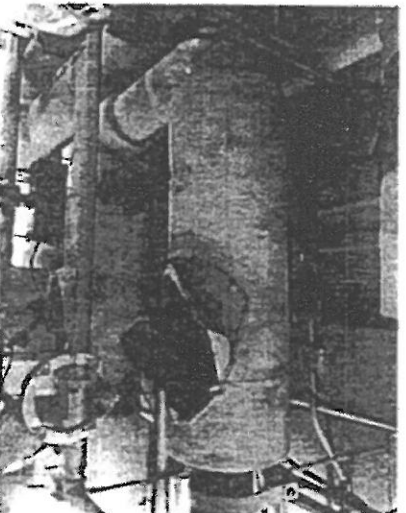
Original isolation valves that are still in place are badly rusted and the handles tend to break off when operation is attempted.

Other piping accessories that have not been recently replaced are severely corroded, indicating elevated moisture, and humidity levels in the mechanical room.

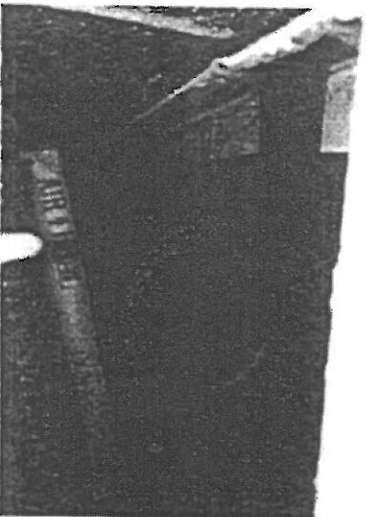
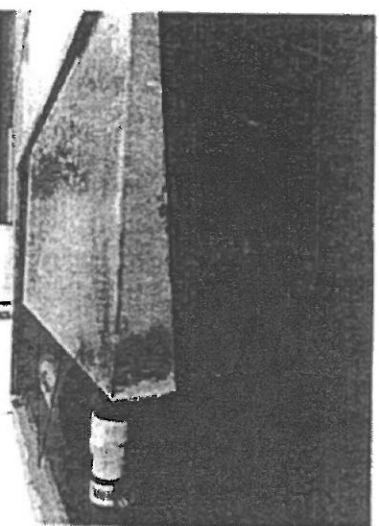
Basement Fancoil Units

Fan coils in the basement appear to be original to building construction and are in bad shape. Most do not function and are in disrepair. Filters are dirty and have not been replaced in some time, control valves are not functioning, and some of the access panels are missing.

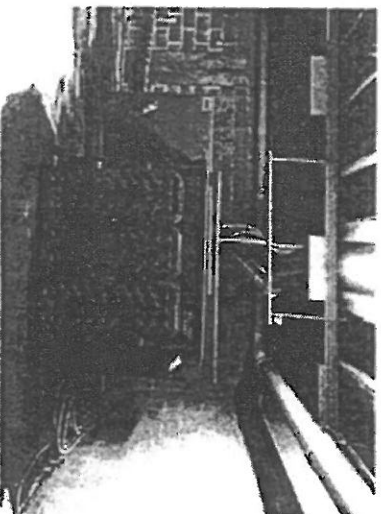
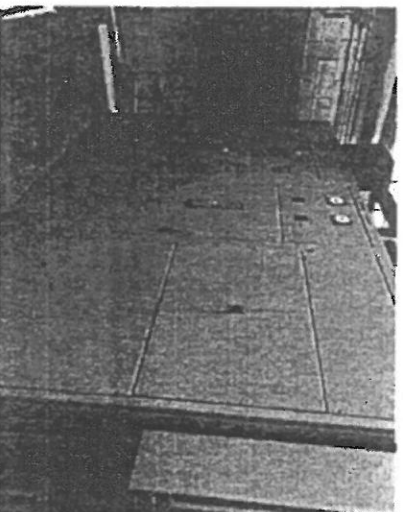
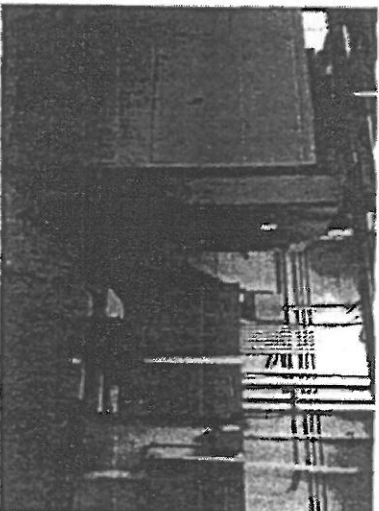
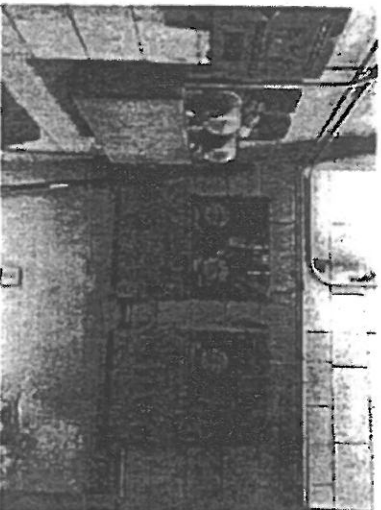
There are additional fusible switches tapped off the bus for additional feeders because of obsolete switchboard and no available space for additional breakers.

The switchboard and busway appear to be original to the building and is approximately 49 years old. The switchboard and busway are obsolete, and replacement parts would be very difficult to obtain. The switchboard is beyond the expected useful life of 30 years according to the "Building Owners and Managers Association" (BOMA).

Based on the condition and age of the switchboard, replacement is recommended.

In addition, we recommend that the service and transformer be relocated to a higher elevation to eliminate the potential for flooding.

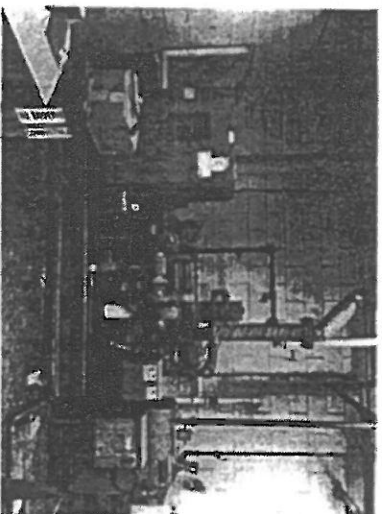
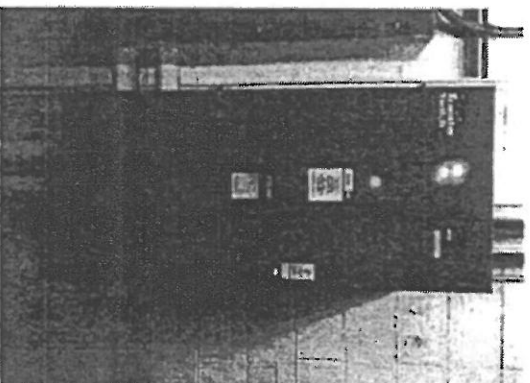
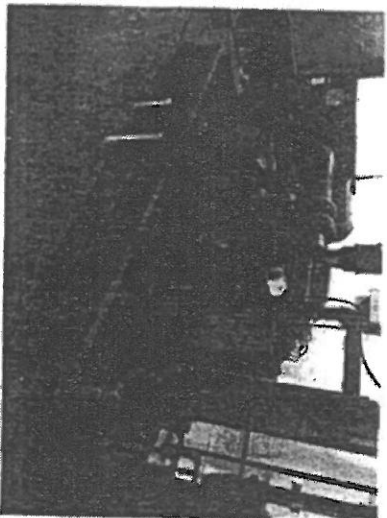
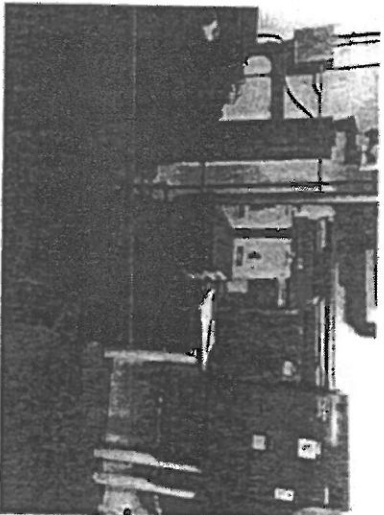
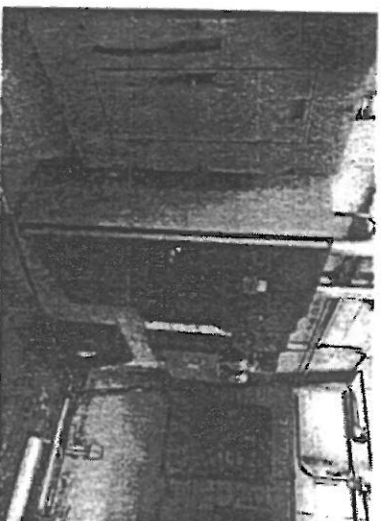
Both generators appear to be in good condition and are exercised on a weekly basis. They were installed around 1998 and should be approximately 21 years old. The expected life of the diesel generator is 20 years, and the expected life of the automatic transfer switch is 25 years according to the "Building Owners and Managers Association" (BOMA).

The diesel generators are just beyond their expected life; however, they have been exercised on a weekly basis and appear to be in good condition for their age.

We recommend that the automatic transfer switches be replaced with 4-pole automatic transfer switches, and that the withstand and close on rating be coordinated with the available fault current

In addition, we recommend that the generators and automatic transfer switches be relocated to a higher elevation to eliminate the potential for flooding.

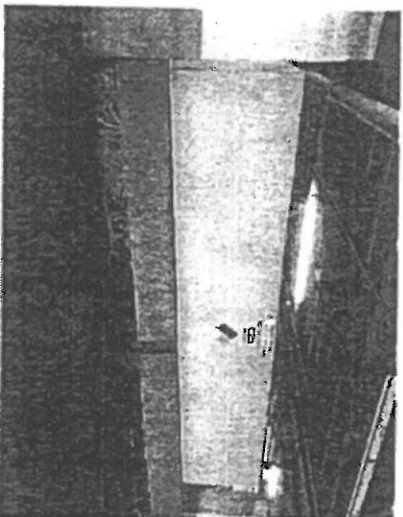
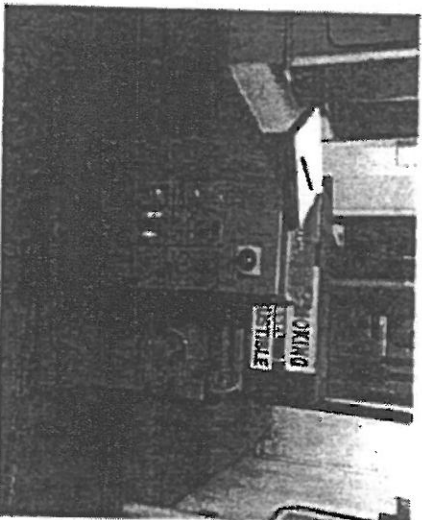
The fuel system to the day tank does not have a return line and return pump to keep the day tank from overflowing in the event that the supply pump did not shut off when called for as recommended by NFPA 31.

We also recommend that the day tanks be replaced with a duplex pump arrangement so that it has a supply pump and a return pump as required by the NFPA 31.

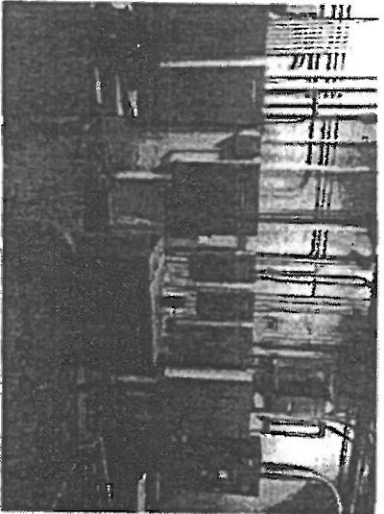
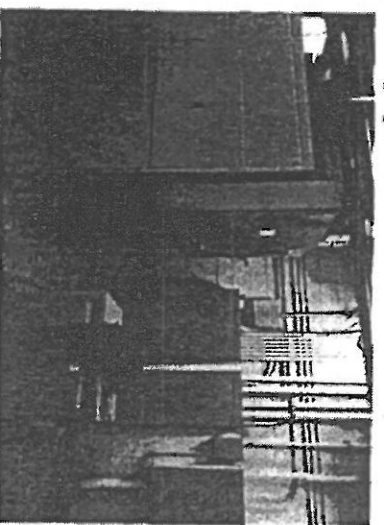
The panelboards, motor control center and dry type transformers appear to be original to the building and are approximately 49 years old. The panelboards and motor control center are obsolete, and replacement parts would be very difficult to obtain. These items are beyond the expected useful life of 30 years according to the "Building Owners and Managers Association" (BOMA).

Based on the condition and age of the panelboards, motor control center and transformers replacement is recommended.

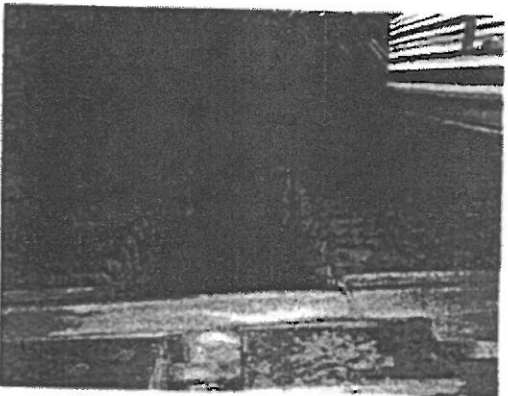
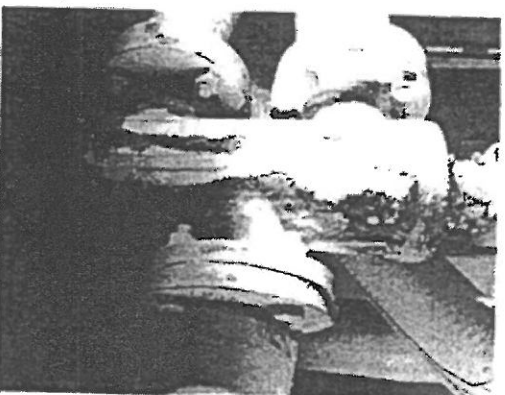
Unit is utilizing an electrostatic filter system, which does not appear to be functional, has missing filter modules from the rack, loose belts on the fans, debris built up on the coil, control valve does not modulate and leaks, coil is not accessible for proper cleaning or service.

Unit should be replaced with a more traditional and standard air handling unit.

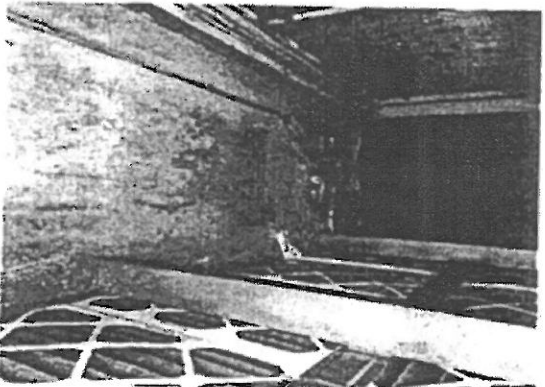
Very poor access to filter section. Filters need to be replaced. There is debris within the unit cabinet, fan belt is loose, drain pan is severely rusted, condensate drain line is broken, visible leak in the hot water heating line.

Debris in unit cabinet.

Unit should be serviced, cleaned and repaired. With proper maintenance, the unit should have another 5 years of service left.

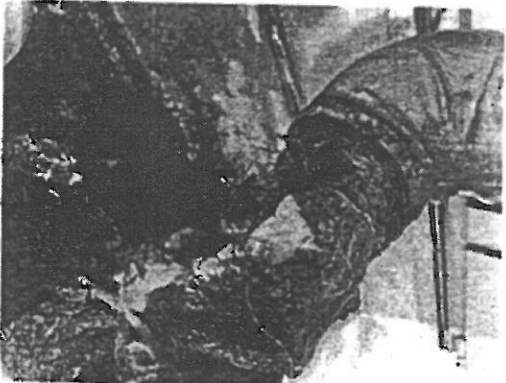
Water leak through a split shut off valve.

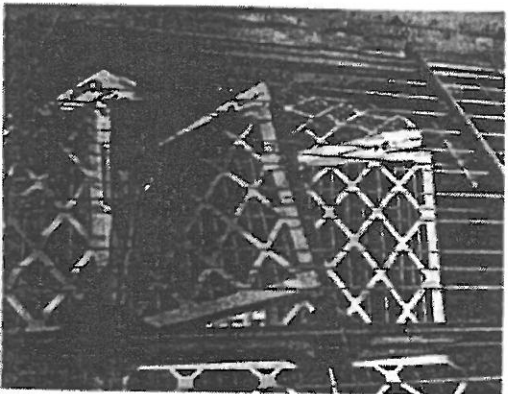
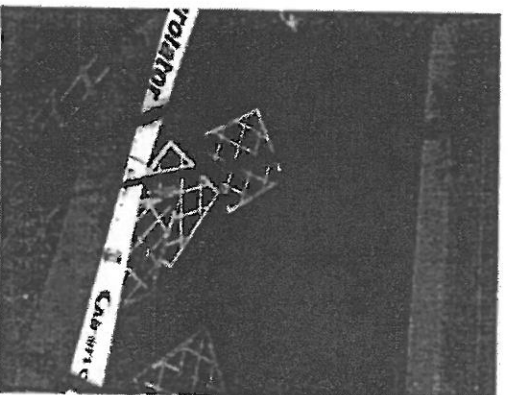
Unit used to utilize an electrostatic filter system, which has been disconnected and regular pleated filters are being used. Multiple filters are out of the tracks, some have been pulled out of the track by airflow due to debris built up. Unit has loose belts on the fans, debris built up on the coil, control valve does not modulate and leaks, coil is not accessible for proper cleaning or service.

Filters out of track

Unit should be replaced with a more traditional and standard air handling unit.

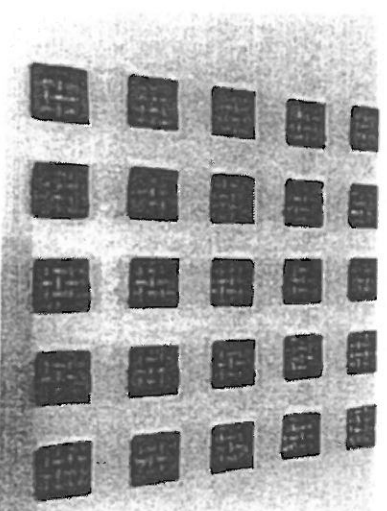
EF-1 was operational but is in poor shape due to age of equipment. It has surpassed it's service life and plans should be made to replace it in the near future. EF-2 has been replaced and is only 5 years old, with proper maintenance it should last another 15 years. Exhaust ductwork and grilles appear dirty and should be cleaned. Exhaust grilles have been painted multiple times over the years which caused a reduction in the open areas of the grilles, which are also clogged up with dust and debris affecting their performance.

Clogged Exhaust Grilles

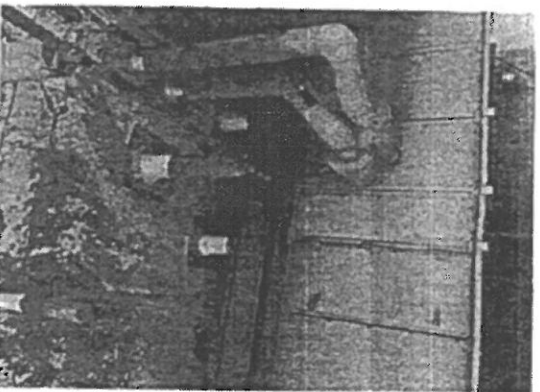
Make-up air is provided by two roof mounted units. Age of the equipment could not be determined due to missing name tags, but they appear to be original to the installation. They appear to be functioning but are in poor shape due to age and exposure to the elements.

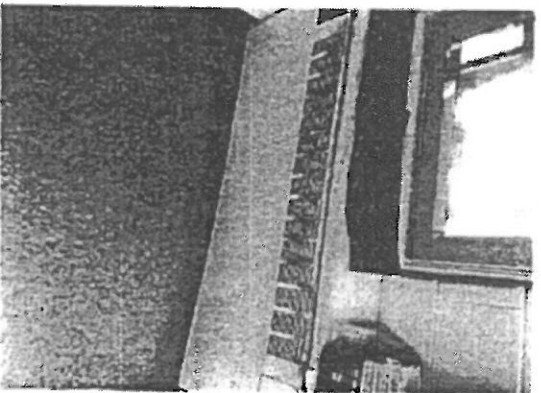
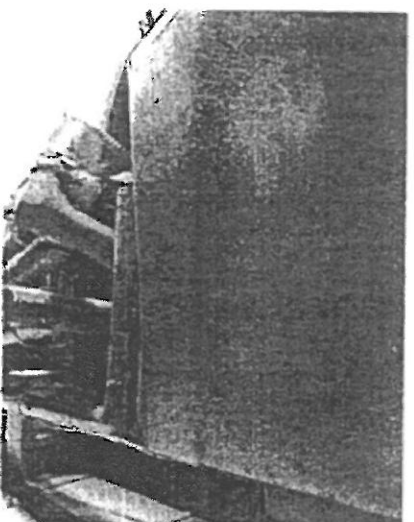
## Fan Coil Units.

Fan coils appear to be in poor shape. According to maintenance the 3-way control valves are non-functioning, so units operate on/off instead of modulating. Coil piping accessories are in poor condition.

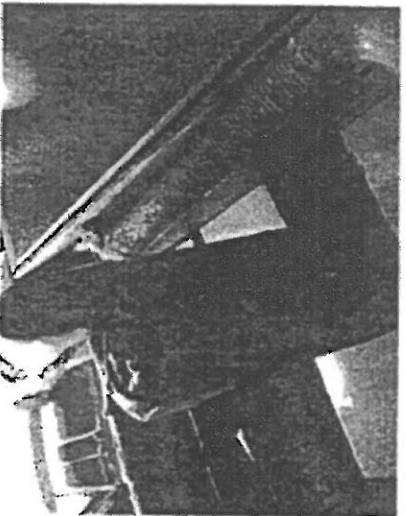
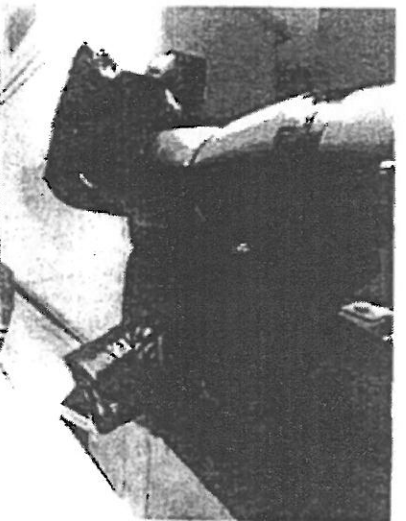
Piping within the building is original and is over 40 years old. Insulation is starting to fail, reducing the efficiency of the system. Some insulation has been patched and reinsulated, but improperly over top of original insulation.
