DEPARTMENT OF THE NAVY
VICE CHIEF OF NAVAL OPERATIONS
2000 NAVY PENTAGON
WASHINGTON DC 20350-2000

FINAL ENDORSEMENT on RDML Christopher J. Cavanaugh, USN ltr 5830 of 14 Jan 22

Subj: COMMAND INVESTIGATION INTO THE 6 MAY 2021 AND 20 NOVEMBER 2021
INCIDENTS AT RED HILL BULK FUEL STORAGE FACILITY

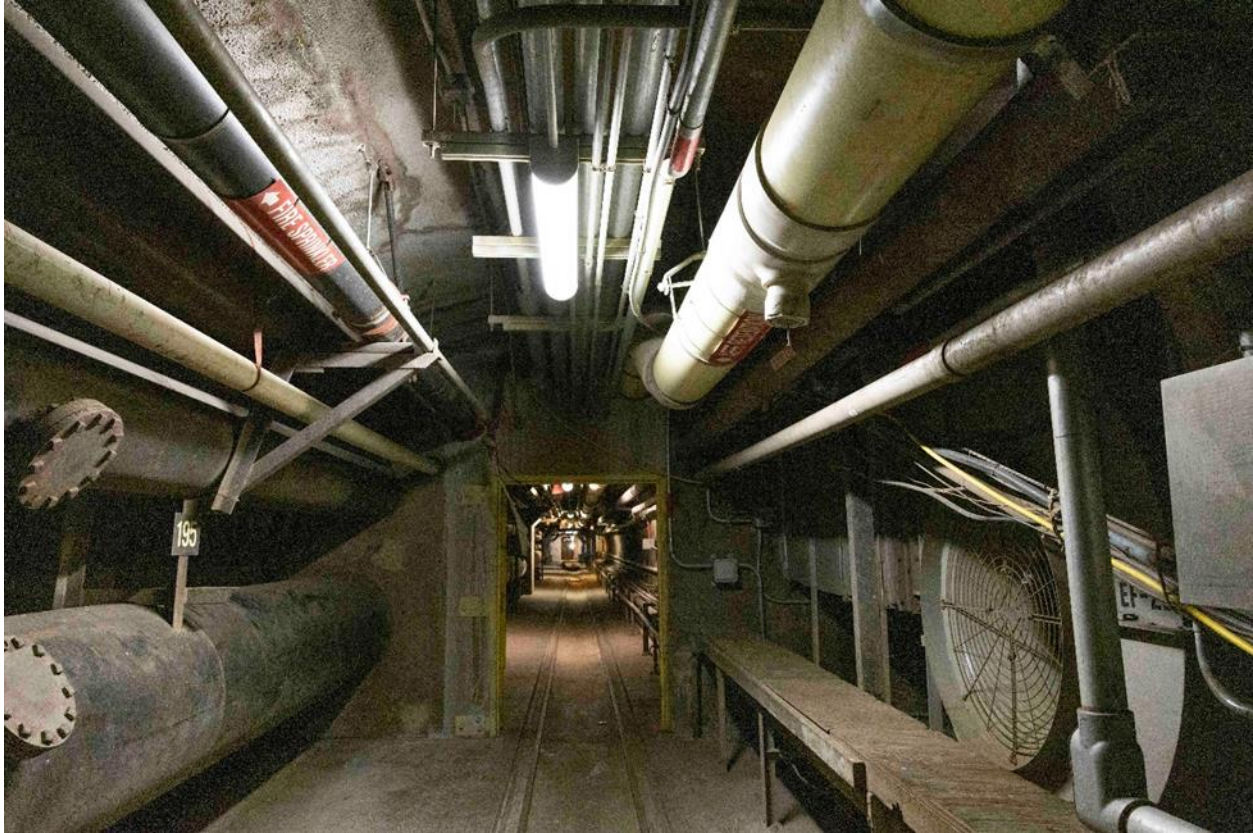
Lower Access Tunnel with AFFF retention line in top right (PVC pipe)

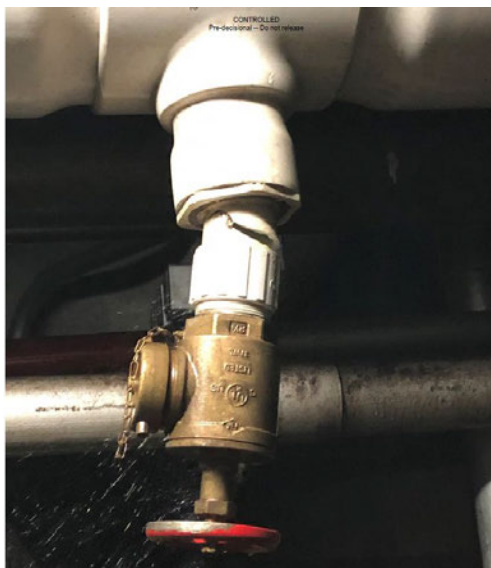
As established in the Cavanaugh Report and updated herein, the AFFF fire suppression system retention line held up to 19,377 gallons of JP-5 fuel from the time of the May spill until the November spill, when a watch stander inadvertently struck a low point drain with the passenger cart of a train, cracking the pipe and spilling the fuel. The below findings of fact focus on the design, installation, induction, and maintenance associated with the AFFF retention line, sump pumps, tank and associated equipment (collectively referred to here as the AFFF waste system).

Cracked Low Point Drain

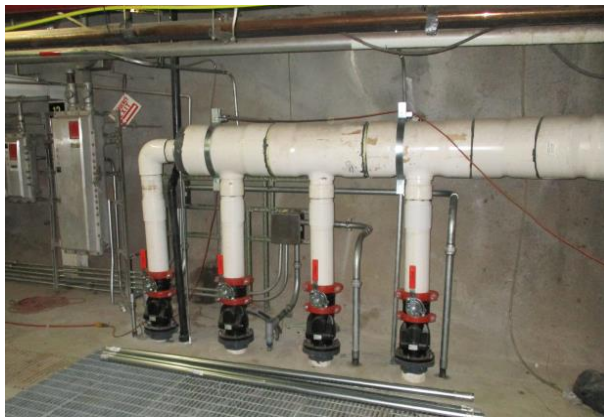
383. On 13 Mar 17, the construction contractor formally notified NAVFAC PAC, in writing, that they constructed the entire AFFF retention line with PVC vice Steel pipe. [Encl (353)]

Original AFFF Retention Line Piping in Immediate Area of an AFFF Sump

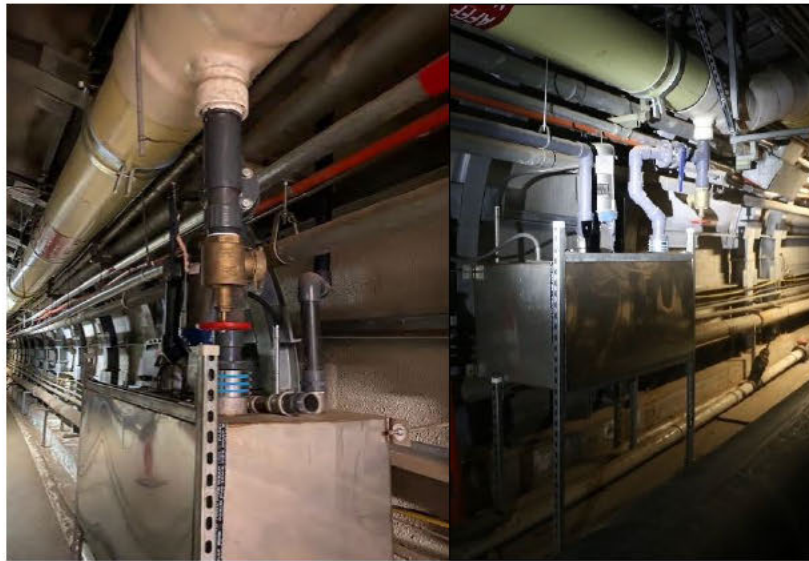
drainage out to a new manual hose connection at the Adit 3 entrance via new 3" PVC piping. This system does not utilize the groundwater sump system. This is the installed configuration today and is in close proximity to the Adit 3 groundwater sump, but does not connect with that sump. This system was not used to drain the AFFF retention line following the November spill. [Encl (354)]

Final Installed Low Point Drain System with PVC Retention Line

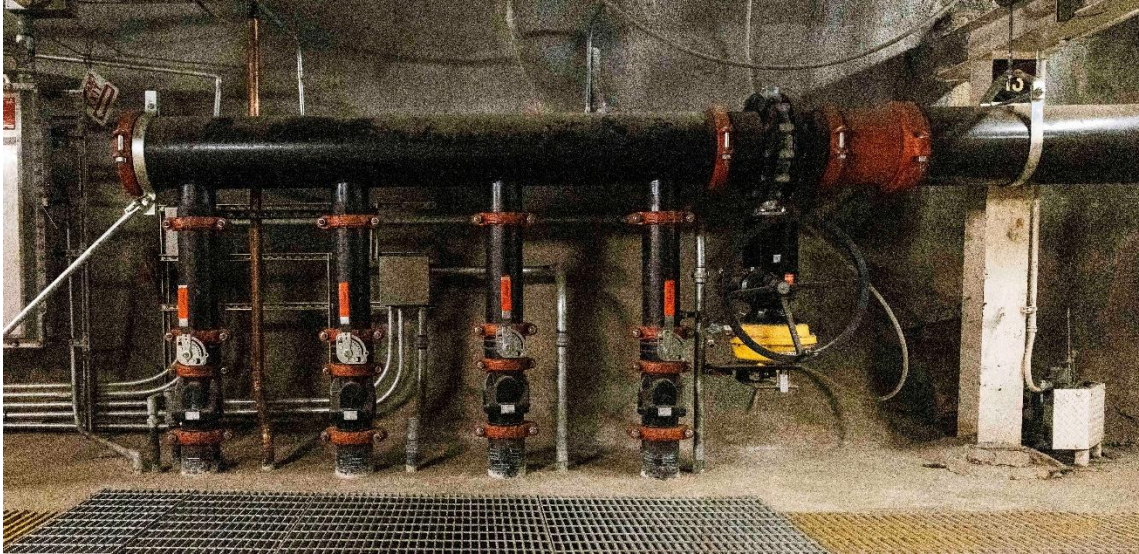
405. On 19 Jun 19, Change R was completed by the construction contractor. This is the configuration today. Commissioning testing was not performed again on the AFFF waste system. However, servicing was performed on the sump pumps (grease, rotation, cleaning) during connection of the new steel piping in the immediate area of the pumps. It was noted at the time that some of the pumps were seized due to lack of preventative maintenance, but were operational at the completion of servicing. [Encls (332), (362), (364)]

Final Change R Piping in Immediate Area of an AFFF Sump

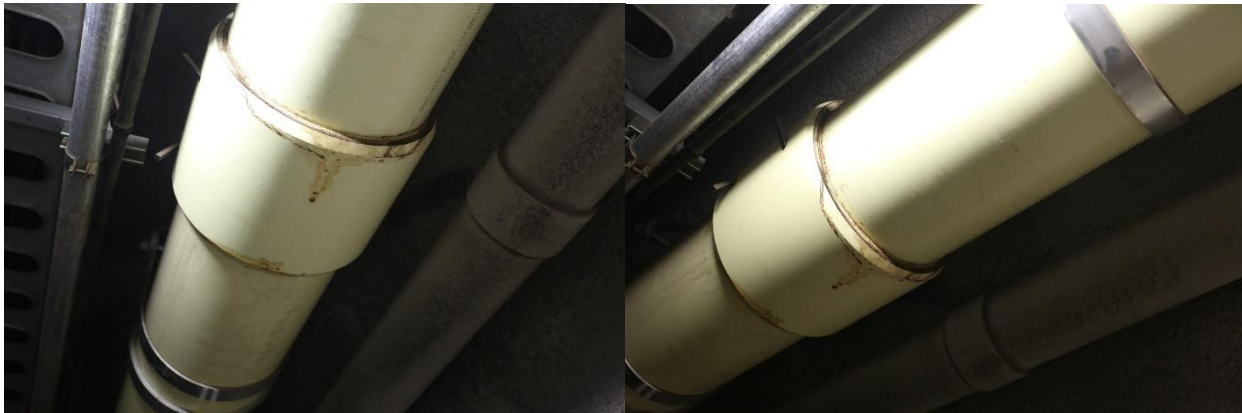
414. On 17 Mar 22, during a walkthrough of Red Hill, the supplement investigation team noted visual evidence of a foreign substance on the outside of the PVC AFFF retention line piping joints that appears to have seeped out.

Installed PVC AFFF Retention Line with Joint Seepage

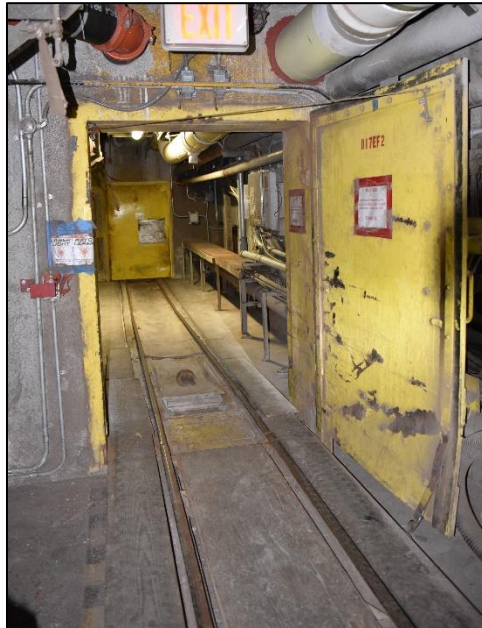
Figure 1: Image of open oil-tight door (foreground) and closed ventilation door on either side of the damaged fire suppression system low point drain valve. [Encl (169)]

178. After driving through the doorway, he again stopped the train and disembarked to close the ventilation control door. As he turned to close the door, he discovered liquid spraying from the low point drain of the fire suppression system retention line. He reported the leak immediately to the CRO. He recognized the source was a non-fuel system, first reporting it was from a sewage line, then fire suppression agent, then water. Finally, he reported the leak as water with a fuel smell. This line should have been empty. [Encls (83), (173)-(186)]
