National Transportation Safety Board

HWY23MH004

HIGHWAY FACTORS GROUP

Group Chair's Factual Report

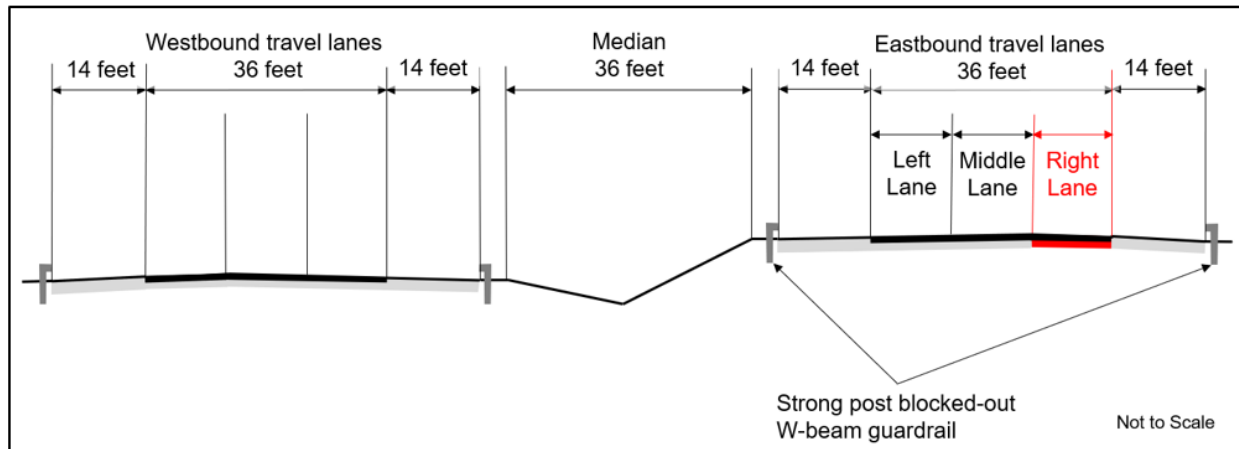
Figure 3 - Typical section for I-64

Figure 3 illustrates the typical section for I-64. The crash occurred in the right lane denoted by the red highlighted text. A paved shoulder existed adjacent to the rightmost and leftmost travel lane that was approximately 14 feet wide. A 36-foot-wide

median separated the eastbound travel lanes from the westbound travel lanes.⁴ A strong post blocked-out W-beam guardrail was continuous along the left shoulder approaching the crash site in both the eastbound and westbound direction of travel.

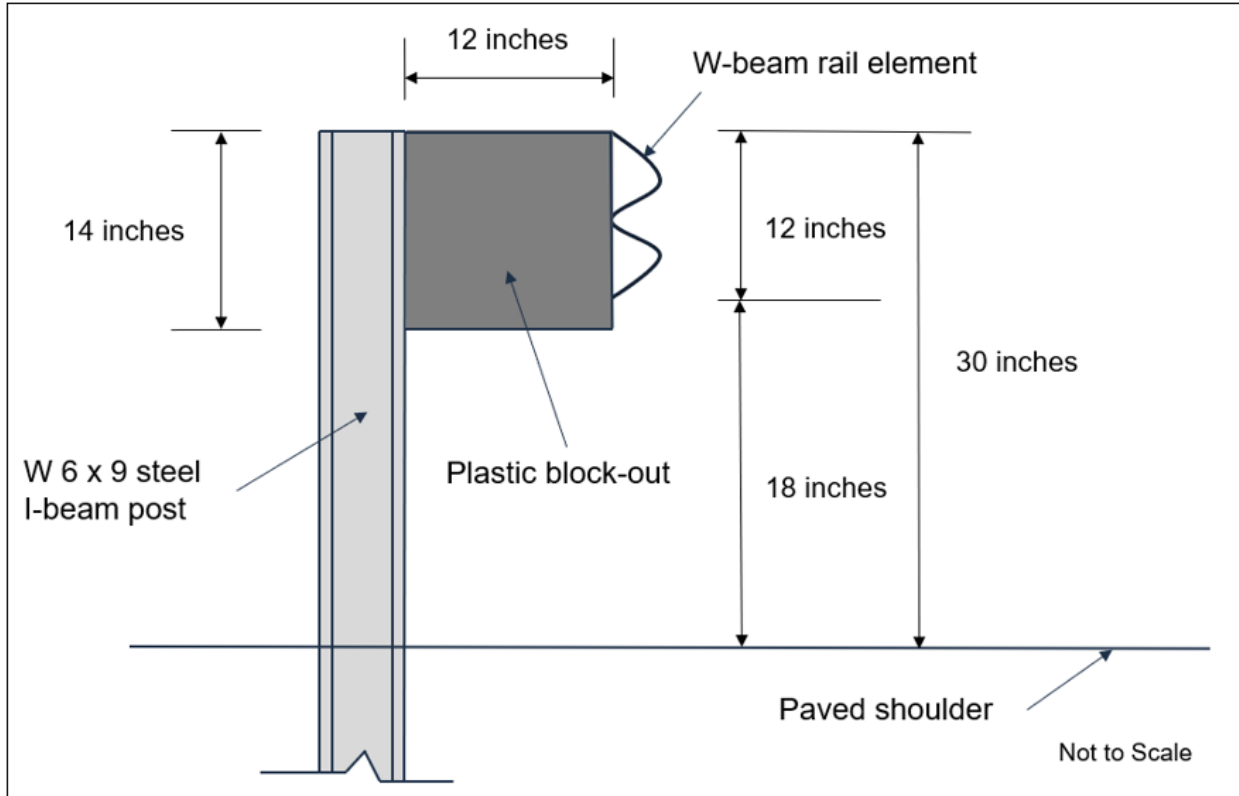
Figure 4 - Strong post blocked-out W-beam guardrail

Figure 4 illustrates the strong post blocked-out W-beam guardrail located in the median.¹⁰ The W-beam rail element was blocked-out from the posts by plastic block-outs measuring 12-inches in length and 14-inches in depth. The strong post blocked-out W-beam guardrail was continuous along the left shoulder approaching the crash site in both the eastbound and westbound direction of travel.

The W-beam rail element was raised approximately 18-inches from the pavement surface. The height of the W-beam rail element was approximately 12 inches. The total height from the pavement surface to the top of the W-beam rail element was approximately 30 inches. The height of the W-beam rail element conformed to the American Association of State Highway and Transportation Officials (AASHTO) *Roadside Design Guide* which states “the nominal mounting height of the rail is 29 inches. A construction tolerance of +/- 1 inch applies to all strong-post W-beam installations”.¹¹

The strong posts that connected to the plastic block-outs consisted of W 6 x 9 steel I-beam posts that were spaced 6 feet 3 inches apart. The W 6 x 9 steel I-beam posts were embedded in the ground.

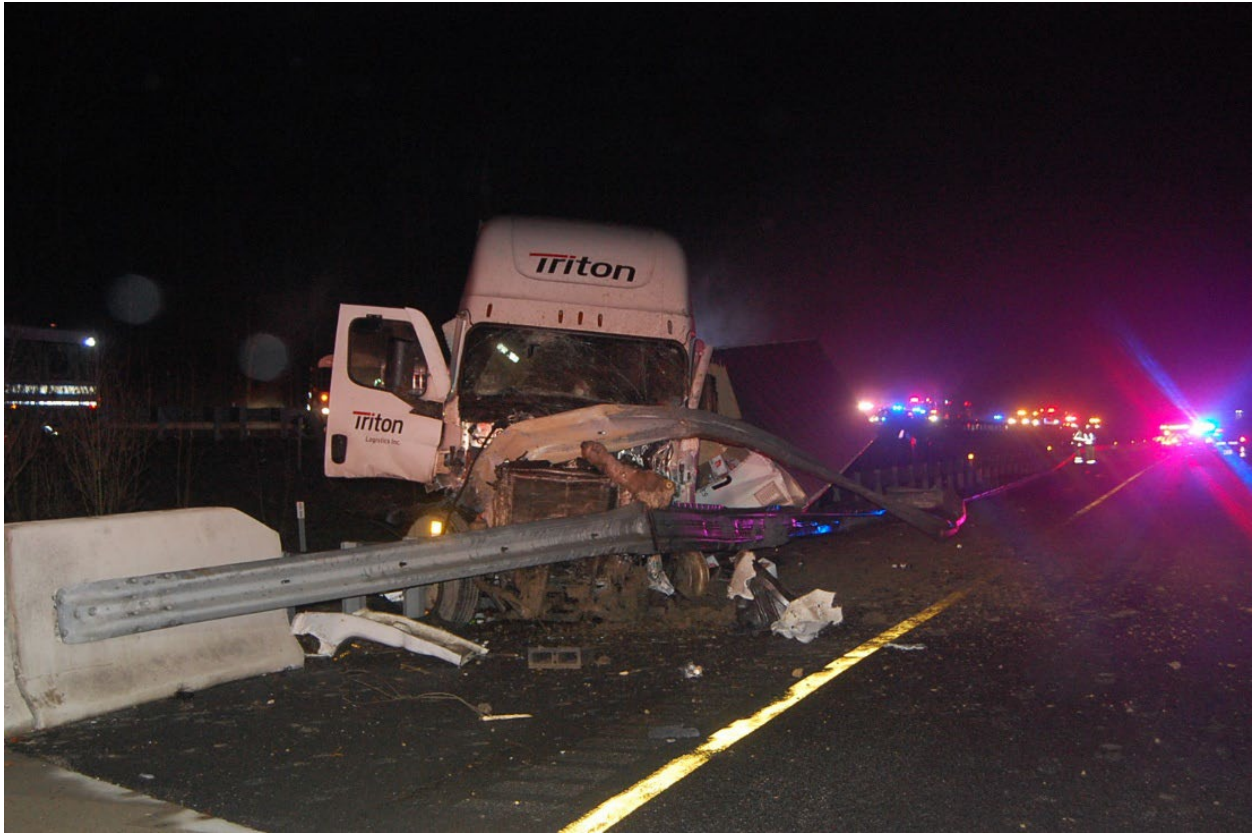
Photographs 1 and 2 show the Freightliner combination vehicle in the median, behind the W-beam guardrail.¹²

Photograph 1 - View of Freightliner combination vehicle in the median, behind the W-beam guardrail standing in the leftmost travel lane in the westbound direction looking to the northwest (Source: Virginia State Police)

NTSB staff inventoried the damaged guardrail on December 18, 2022. The total distance of displaced guardrail in the eastbound direction of travel was approximately 210 feet. The total number of W 6 x 9 steel I-beam posts deformed was 34.

The total distance of displaced guardrail in which W 6 x 9 steel I-beam posts were deformed or missing in the westbound direction of travel was approximately 64 feet. The total distance of missing W-beam rail element in which the W 6 x 9 steel I-beam posts were intact in the westbound direction of travel was approximately 164 feet.

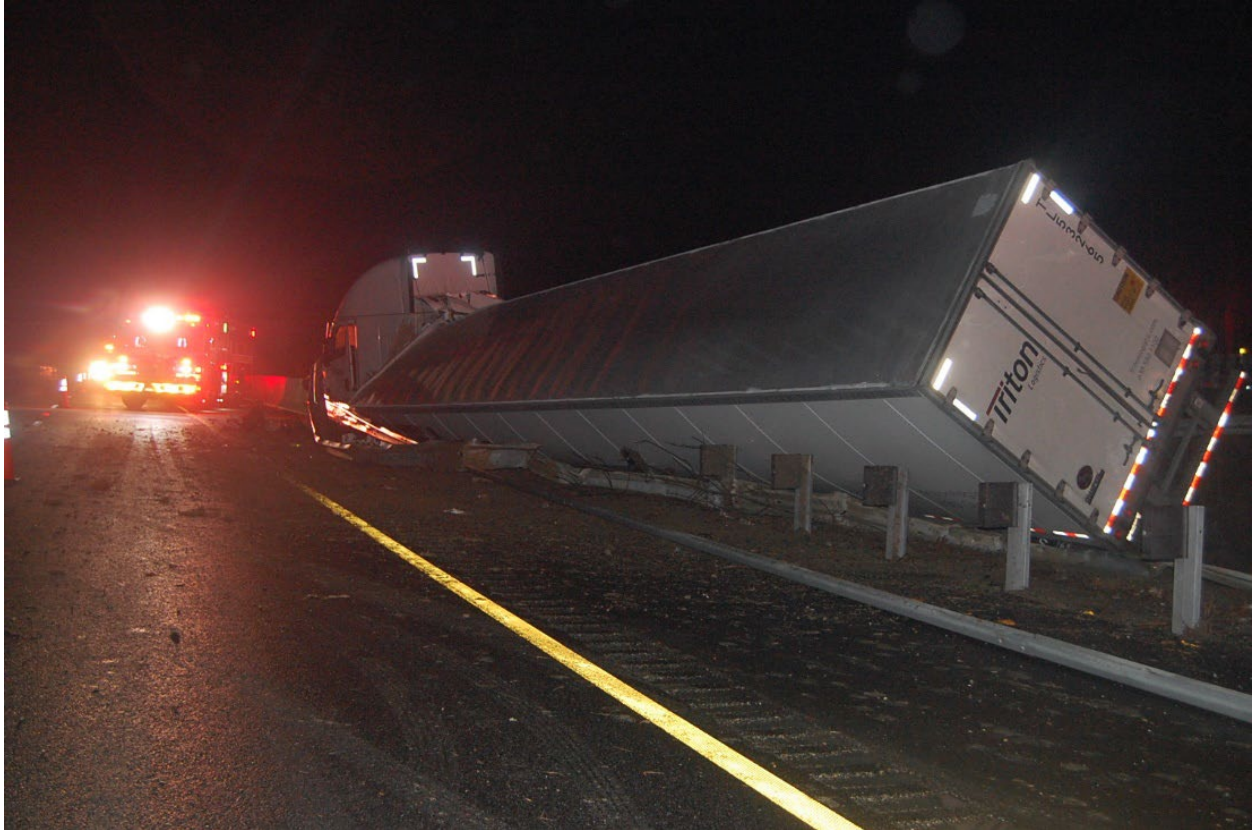
Photograph 2 - View of Freightliner combination vehicle in the median, behind the W-beam guardrail standing in the leftmost travel lane in the westbound direction looking to the southeast (Source: Virginia State Police)
