# PORTSMOUTH GIVIG CENTER

# CONDITION ASSESSMENT

**Final Submittal**

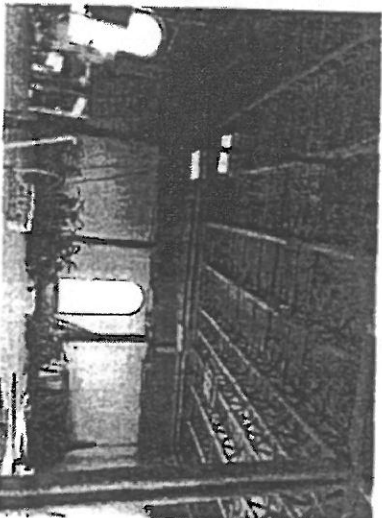
The branch circuits and feeders in this area of the facility appeared to be copper in metal raceway and original to the building.

Type "MC" cable appeared to be used for minor circuit revisions in these spaces.

Based on the existing drawing and electrical practice at the time of construction, we expect that the branch circuits included multi-circuit homeruns with a common neutral and no branch circuit equipment grounding conductor. With the new electronic ballast for the lighting, third harmonics created on the common neutrals could result in the neutral conductors being overloaded. If equipment grounding conductors are not included in the branch circuits, the loss of grounds could be expected due to the deterioration of the metal raceway in this area of the building.

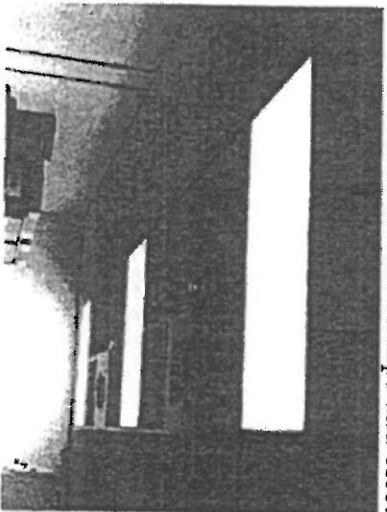
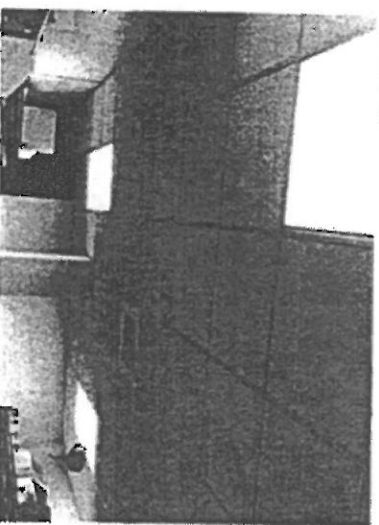
Lighting in the first floor office and administrative spaces generally consisted of recessed troffers with T-8 fluorescent lamps and electronic ballasts.

The lighting on the first floor appeared to be in fair condition with some maintenance required and dated lighting controls.

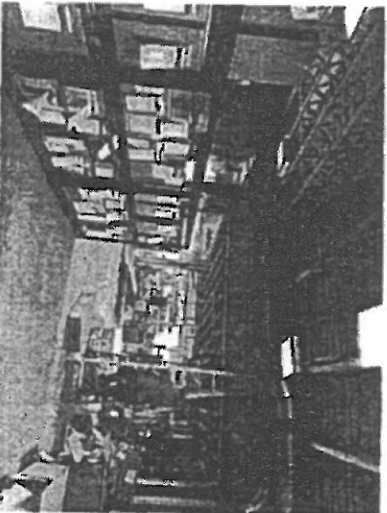
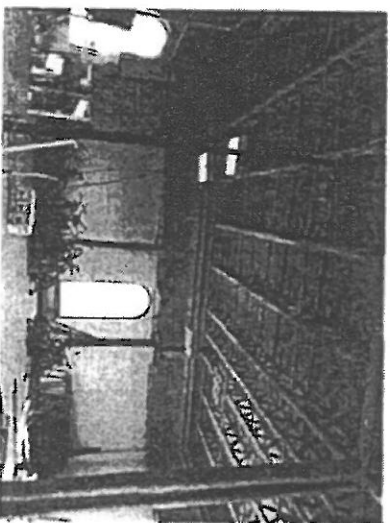
The lighting in the second floor and Police Storage areas generally consisted of 2x2, recessed, 3-lamp, parabolic fixtures with three T-8 fluorescent lamps and electronic ballasts suspended with wires.

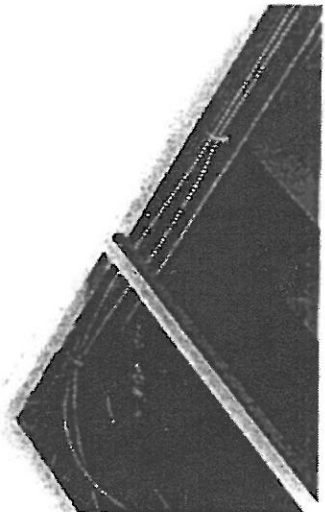
The branch circuits and feeders in this area of the facility appeared to be copper in metal raceway and were original.

Type "MC" cable appeared to be used for minor circuit revisions in these spaces.

Based on the existing drawing and electrical practice at the time of construction, we expect that the branch circuits included multi-circuit homeruns with a common neutral and no branch circuit equipment grounding conductor. With the new electronic ballast for the lighting and electronic power supply, third harmonics created on the common neutrals could result in the neutral conductors being overloaded. If equipment grounding conductors are not included in the branch circuits the loss of grounds could be expected due to the deterioration of the metal raceway in this area of the building.

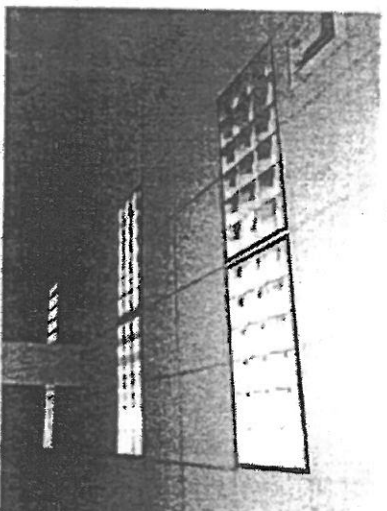
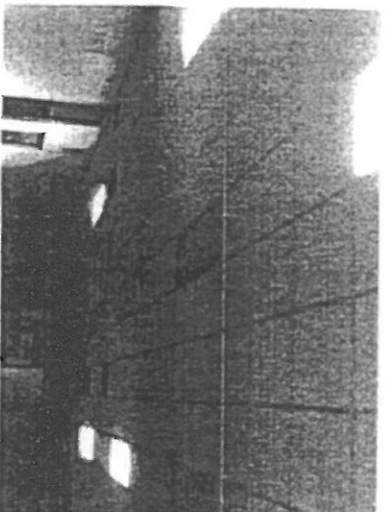
Lighting in the office, corridor and associated areas generally consisted of recessed, 2x4 parabolic troffers with T-8 fluorescent lamps and electronic ballasts.

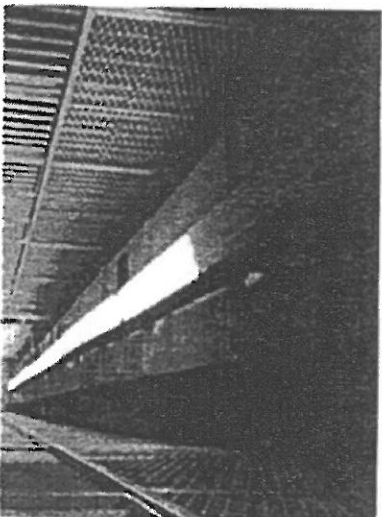
Lighting in the Jail Corridors generally consisted of 1x4, vapor-proof with T-8 fluorescent lamps and electronic ballasts.

The lighting appeared to be in fair condition.

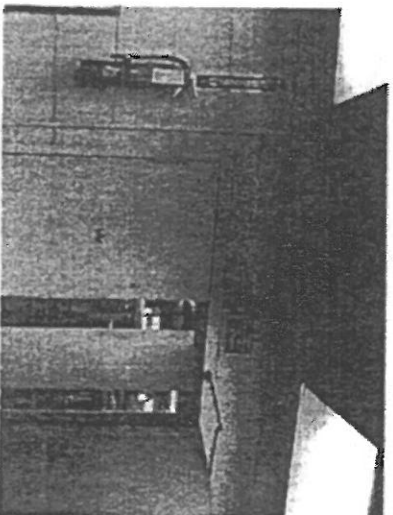
The lighting in area with a finished SAP ceiling consisted of 2x4 recessed troffer.
